WDOT-Skokomish Site near Potlatch

Volume 1. Rapid Infiltration Hydrogeologic Study

*by
Barbara M. Carey*

Environmental Assessment Program
Olympia, Washington 98504-7710

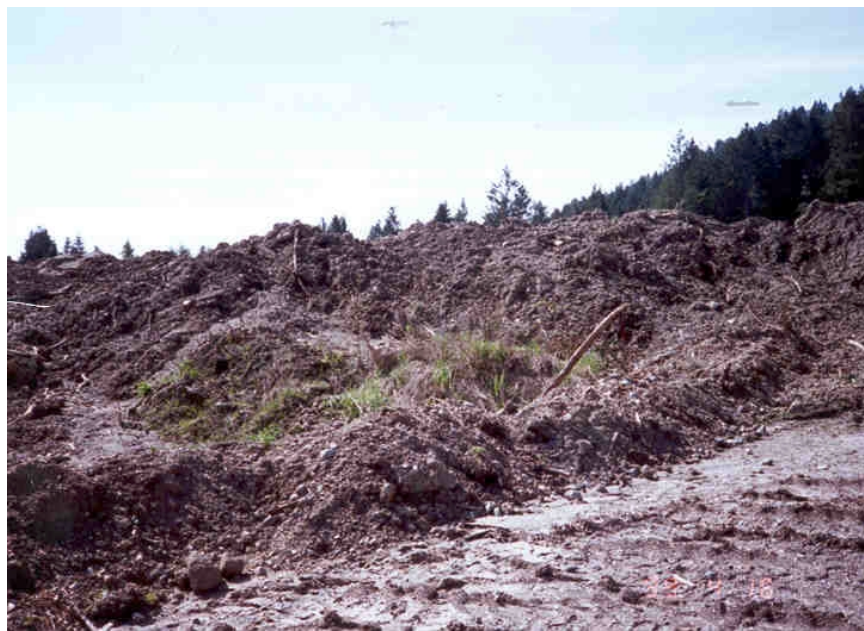
Figure 3. Landslide debris placed at the WDOT site on April 16, 1999.

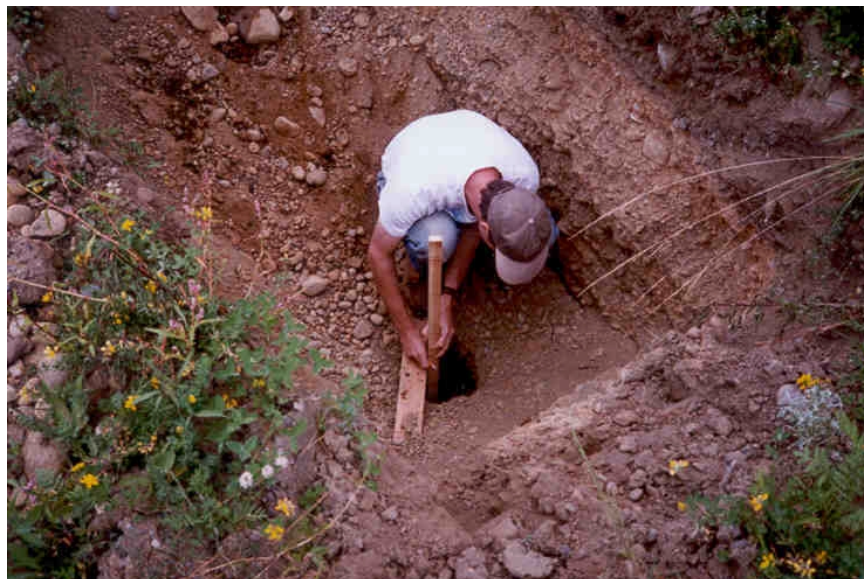
Figure 8. Percolation pit in native soils.
